Manhole Inspection Summary

Manhole # S49EE_031MH

Inspection ☐ Is Incomplete Rating: **3) Fair**

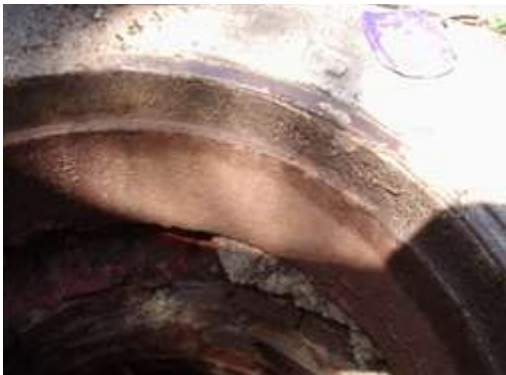
Defect 1

Infiltration: ☐ None ☐ Joint ☐ Cracks ☒ **Mortar** ☐ Roots ☐ Wall

Infiltration: ☐ None ☐ Joint ☐ Cracks ☐ Mortar ☐ Roots ☒ **Wall**

infiltration

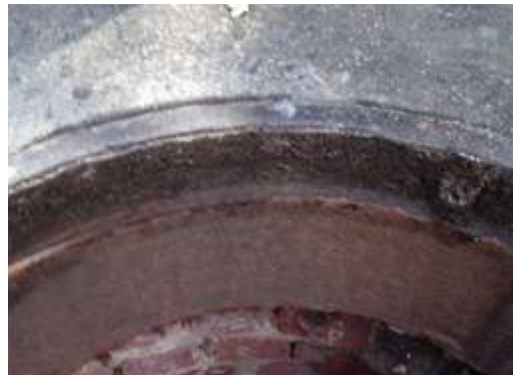
Defect 2

frame leaks

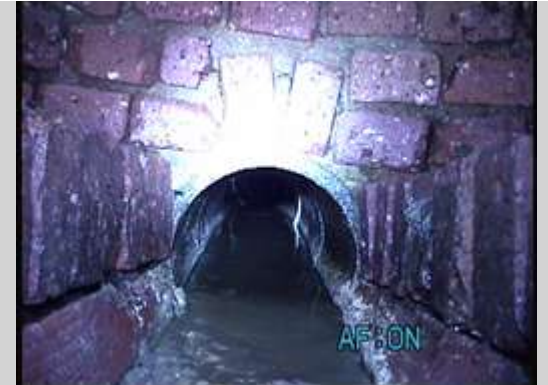
12 O'Clock Outflow

8 in. Circular Gravity Sewer
Pipe Out @ 12 O'Clock

Pipe Height: **8.4** (in.) Rod and Bar (Angled)
Pipe Material: **Clay** ☐ Pipe Lined
Invert Depth: **10.65** (ft.) Flow Characteristics: **Fast**
Deposits: ☒ None ☐ Mud ☐ Sludge ☐ Debris ☐ Grease
Silt Depth: (in.) Deposits Extent:
Infiltration: **None** Pipe Seal Cond: **Sound**

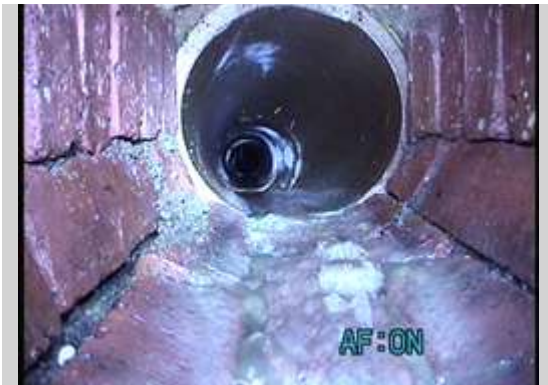
6 O'Clock Inflow

8 in. Circular Gravity Sewer
Pipe In @ 6 O'Clock

Pipe Height: **8.4** (in.) Rod and Bar (Angled)
Pipe Material: **Clay** ☐ Pipe Lined
Invert Depth: **10.20** (ft.) Flow Characteristics: **Fast**
Deposits: ☒ None ☐ Mud ☐ Sludge ☐ Debris ☐ Grease
Silt Depth: (in.) Deposits Extent:
Infiltration: **None** Pipe Seal Cond: **Sound**
